THE MABLE HOUSE

Mableton, Georgia

Historic Structure Report

Conservation of Historic Building Materials Class
Heritage Preservation Graduate Program
Georgia State University

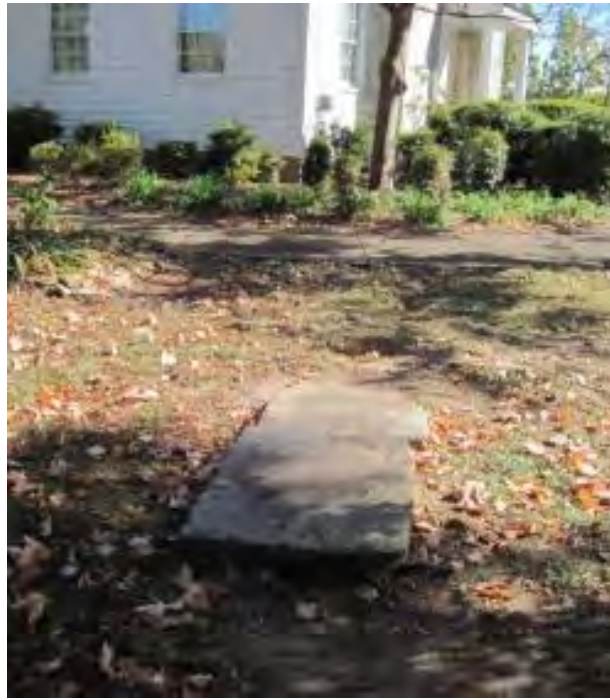
Figure 14. (Photo 9) View of cracked hearthstone, looking southeast

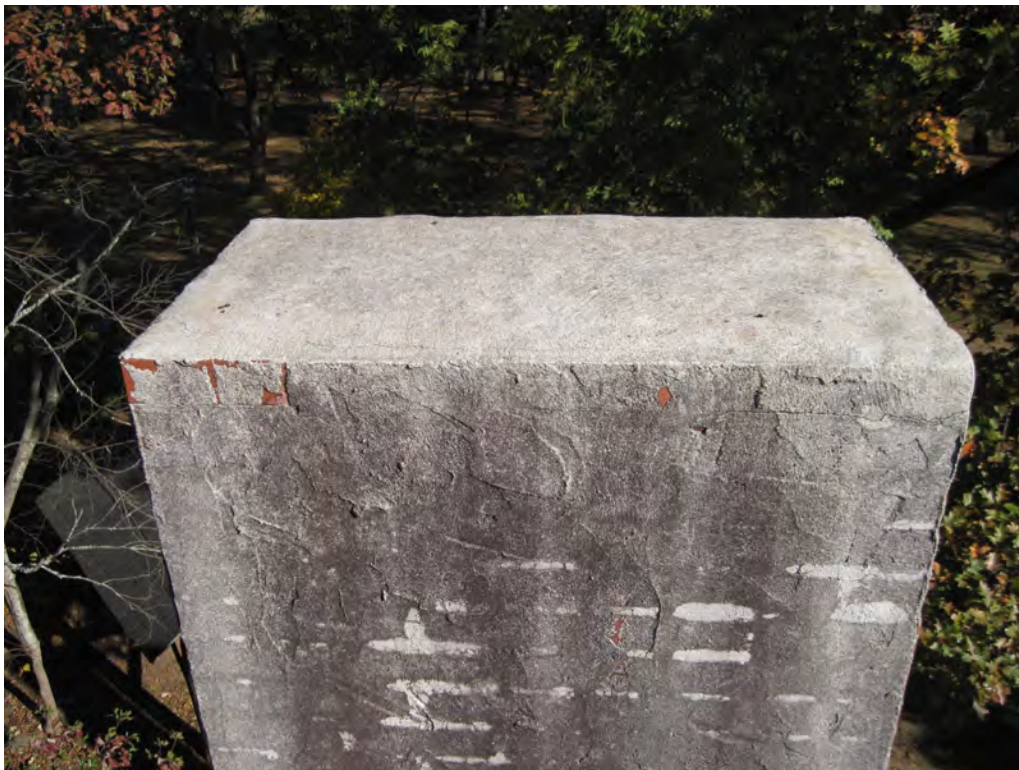
Figure 18. (Photo 12) View of concrete cap on northwest chimney

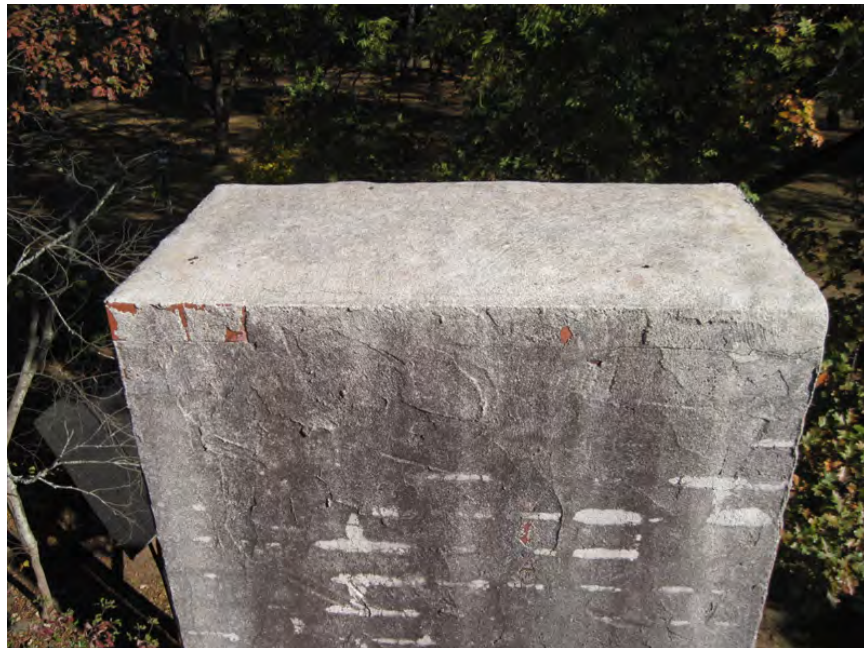
Figure 30. (Photo 20) View of concrete cap on northwest chimney

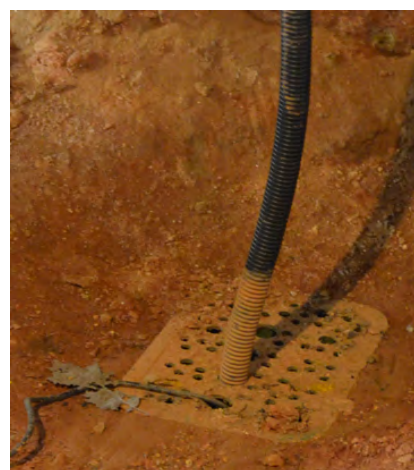
Figure 34. (Photo 34) Sump pump in earth floor of dug out area

amount of moisture is evidenced by staining on the pipe that carries water from the sump pump to the exterior of the building (Figure 34, Photo 24)

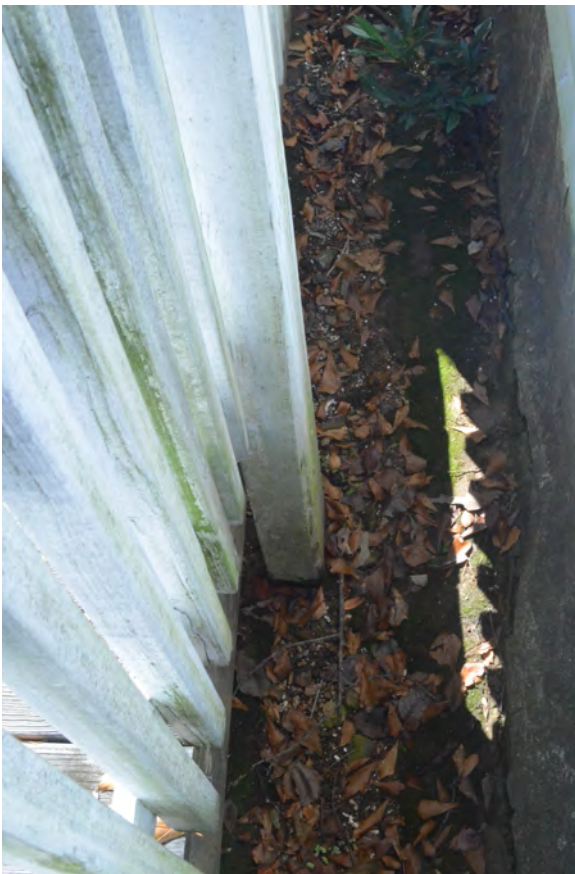
Figure 114. (Photo 97) Large microclimate of microbial growth and damp ground behind accessibility ramp

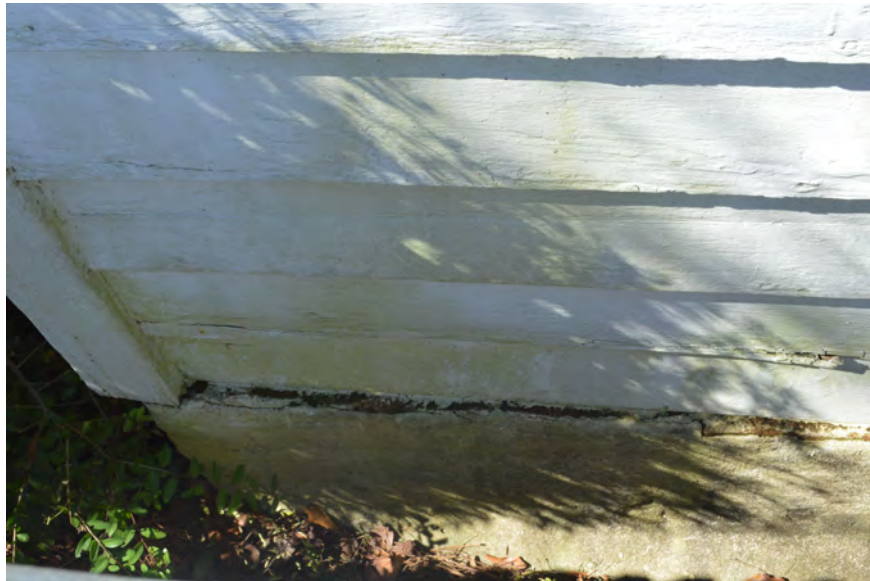
Figure 115. (Photo 98) Microclimate behind accessibility ramp and bush on southeast corner of structure; foundation extends past siding, creating an opportunity for water to enter the building

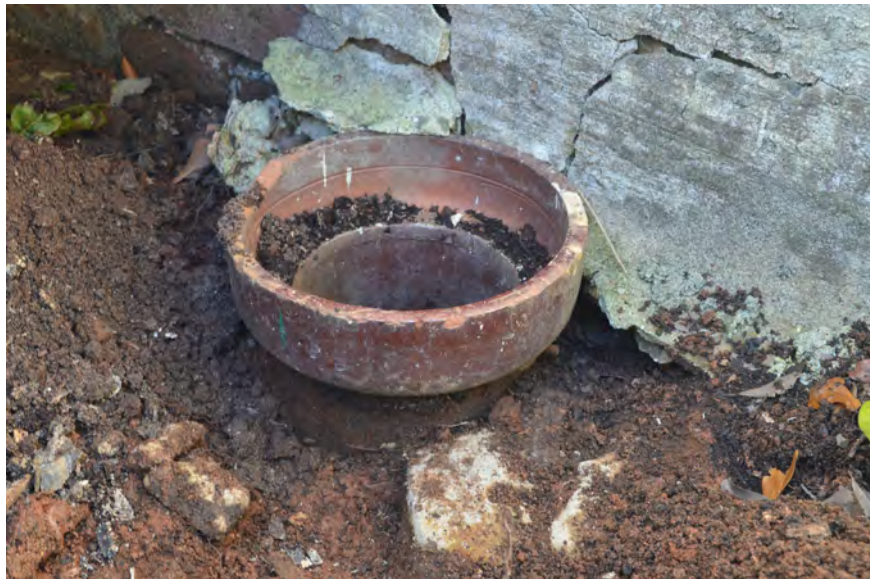
Figure 116. (Photo 99) Terracotta drainage hole on east facade

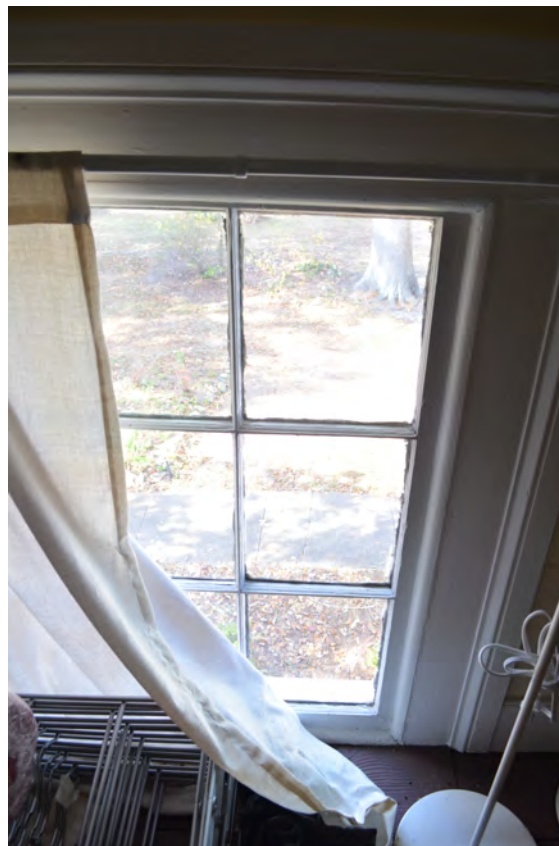
Figure 79. (Photo 66) W20 and W21 on east wall are set directly in contact with the floor

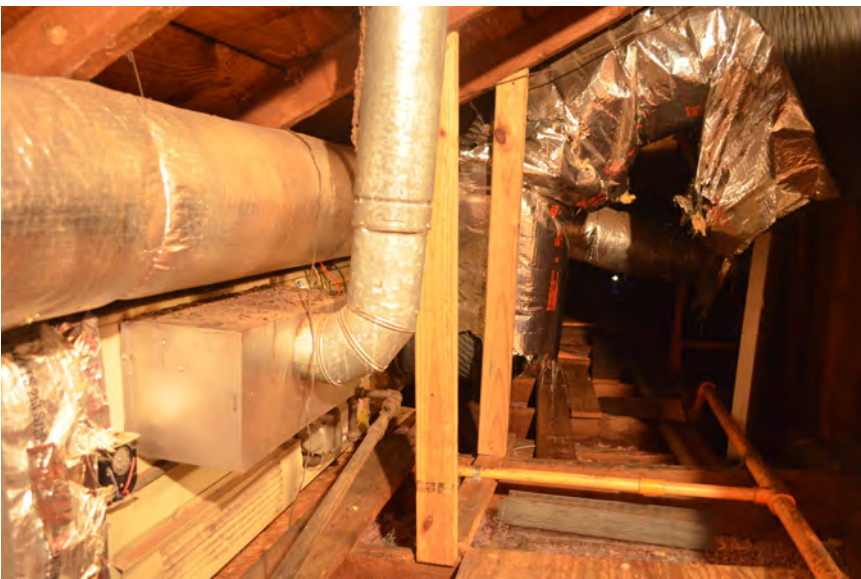
Figure 91. (Photo 76) Old furnace in room 204, servicing the second floor.

- Replace the furnace in the attic (room 204), above room 101B (see floor plan, page XX). The evaporation pan designed to collect water from condensation has previously been filled and then overflowed.
